**Reconstruction of Old Lake Wilson Road (CR 545)  
Widening Project Development and Environment (PD&E)  
Study from County Road 532 to South of Sinclair Road**

**Osceola County**

**FINAL CONCEPTUAL BRIDGE HYDRAULICS ASSESSMENT**

**March 2022**

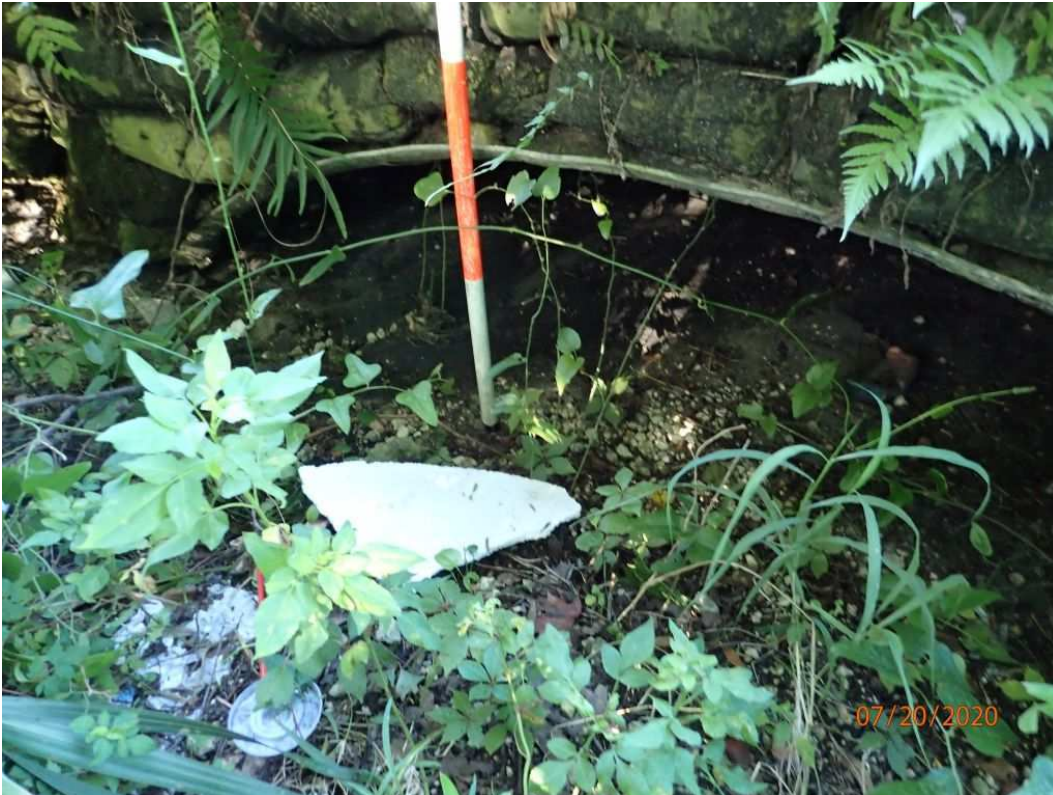
Photo 1: Element 8290: Build up in Pipe 1

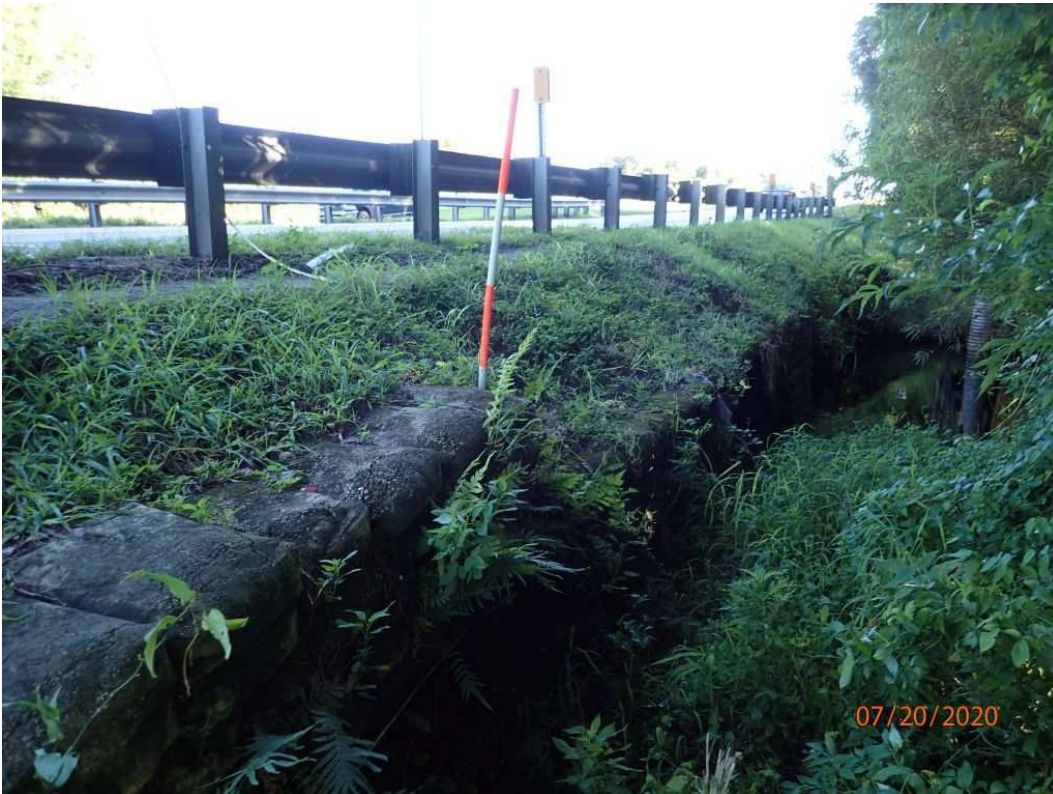
Photo 2: Element 8477: Sand cement rip rap bags missing from the east headwall at Pipe 1

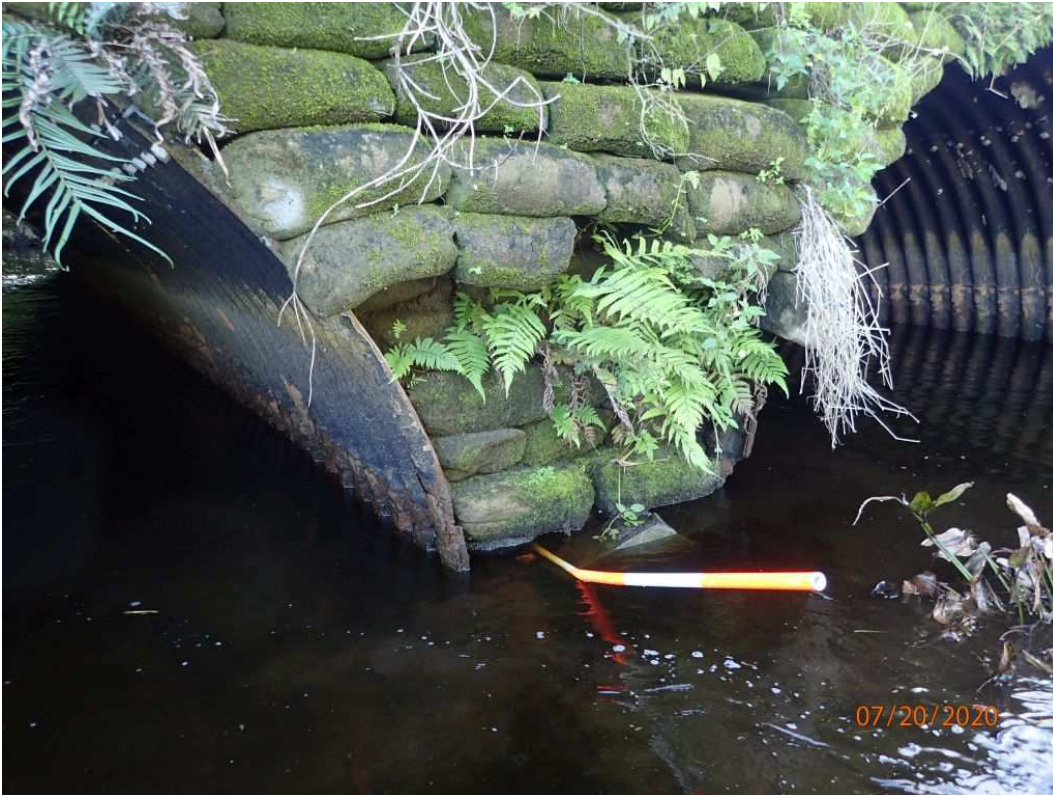
Photo 3: Element 8477: Missing bags from the west headwall between Pipes 3 and 4

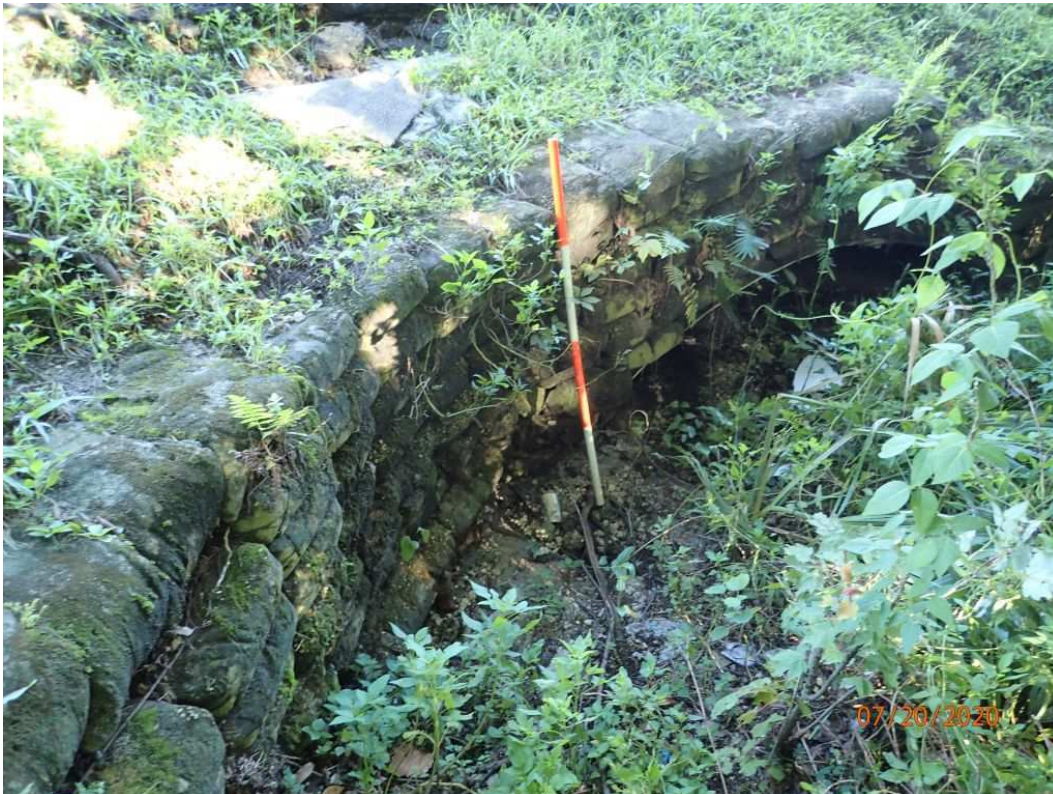
Photo 4: Element 8477: Settled sand cement rip rap bags in the east headwall over Pipe 1

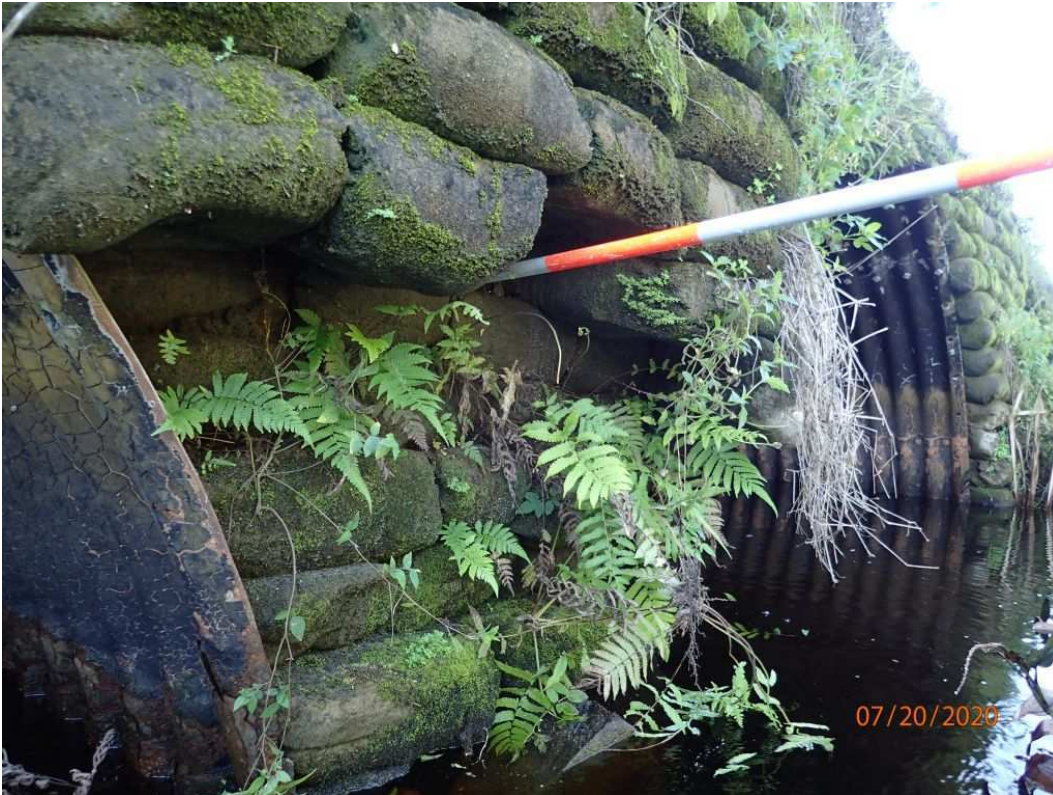
Photo 5: Element 8477: Vegetation growing through the joints of the west headwall

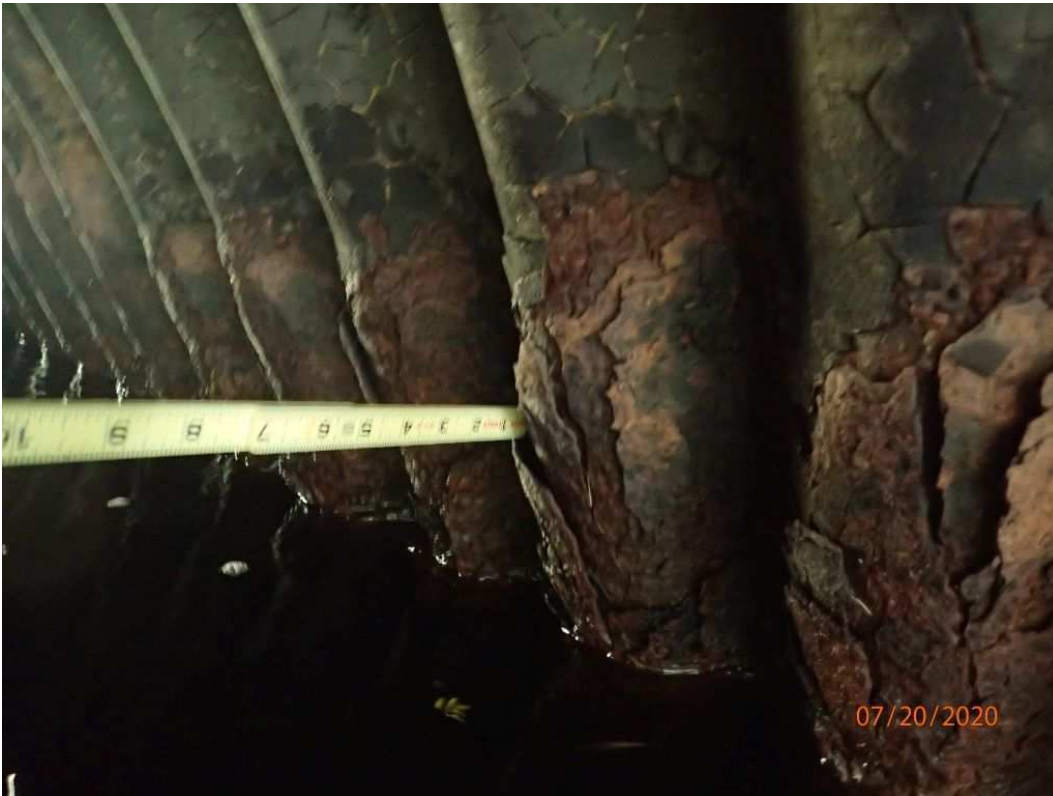
Photo 6: Element 240: Delaminative corrosion on pipes sidewalls and connecting hardware and failed bituminous/galvanized coatings of pipes

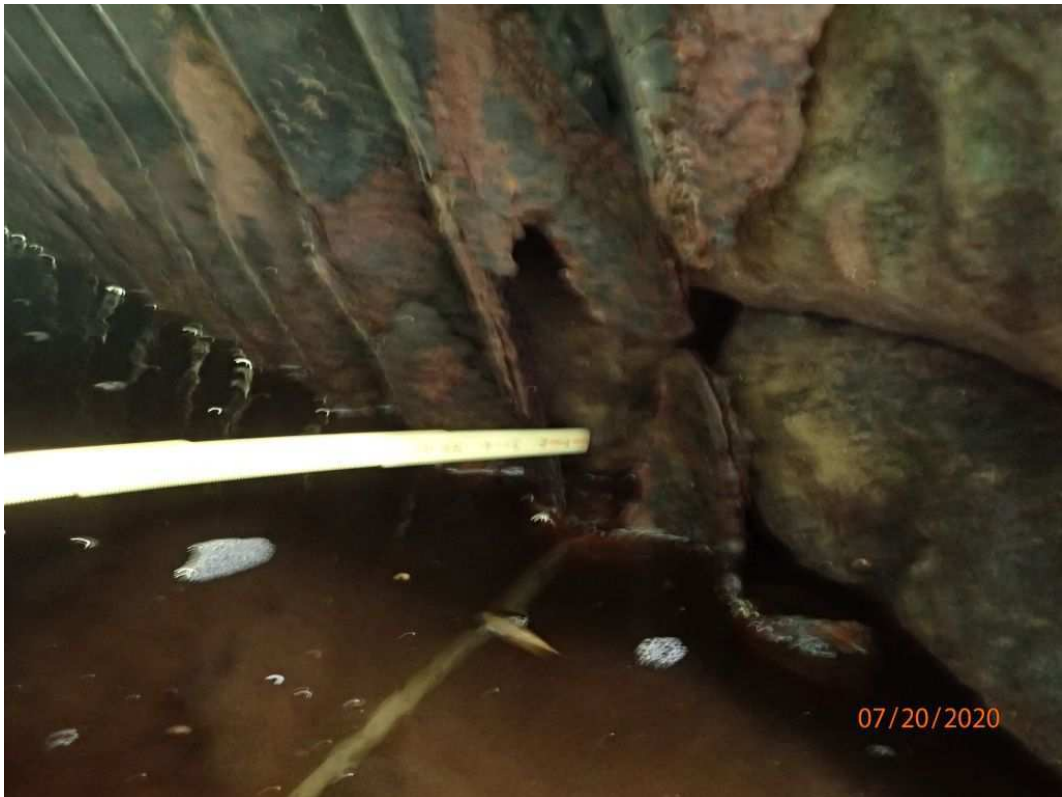
Photo 7: Element 240: Corrosion hole at the east end of Pipe 3

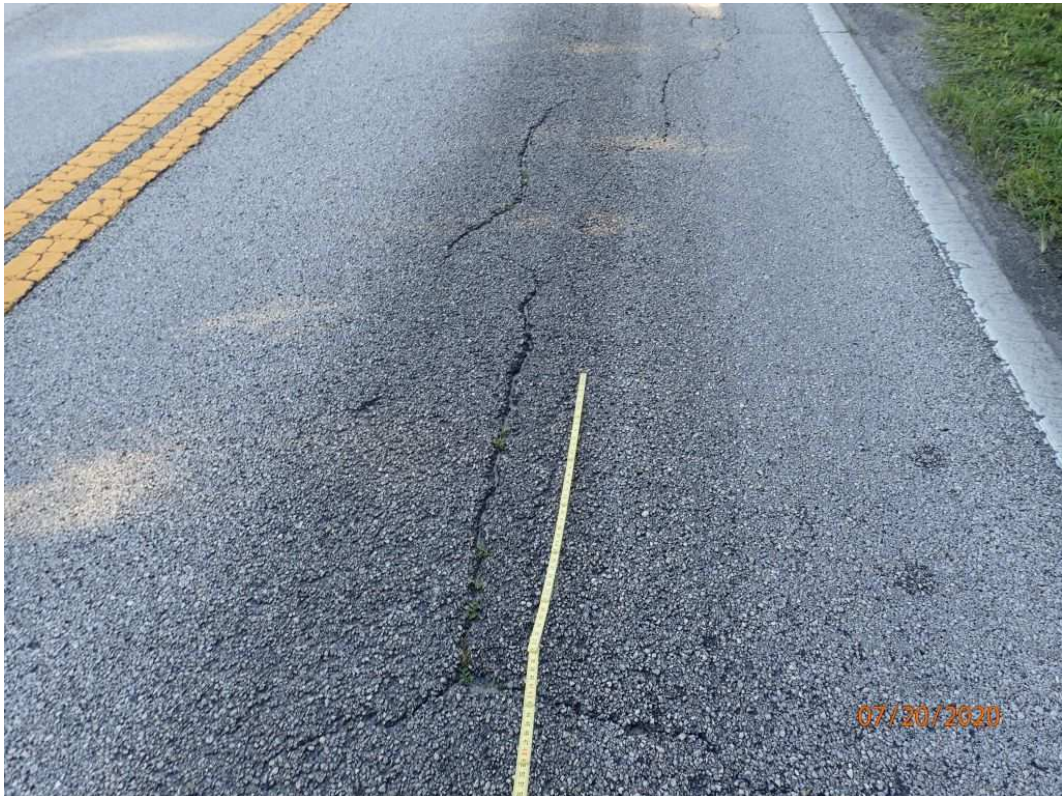
Photo 8: Inspection Notes: Crack in the asphalt surfacing over and approaching the structure

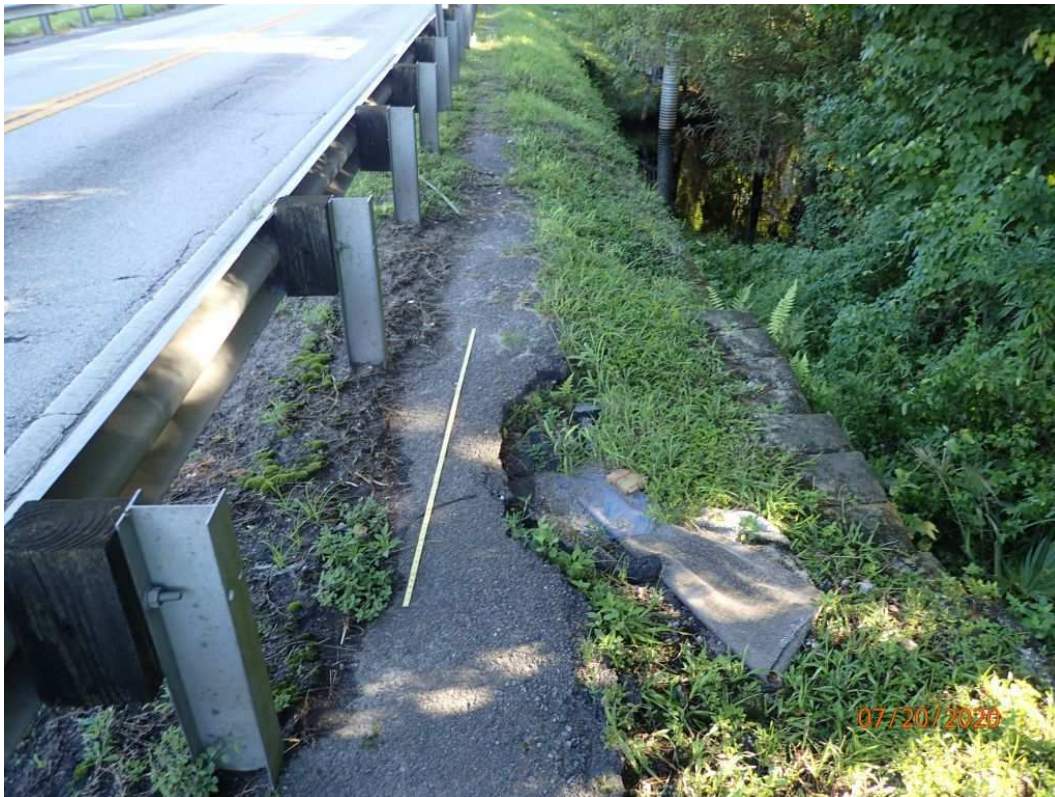
Photo 9: Inspection Notes: Washout in the west asphalt mowing strip

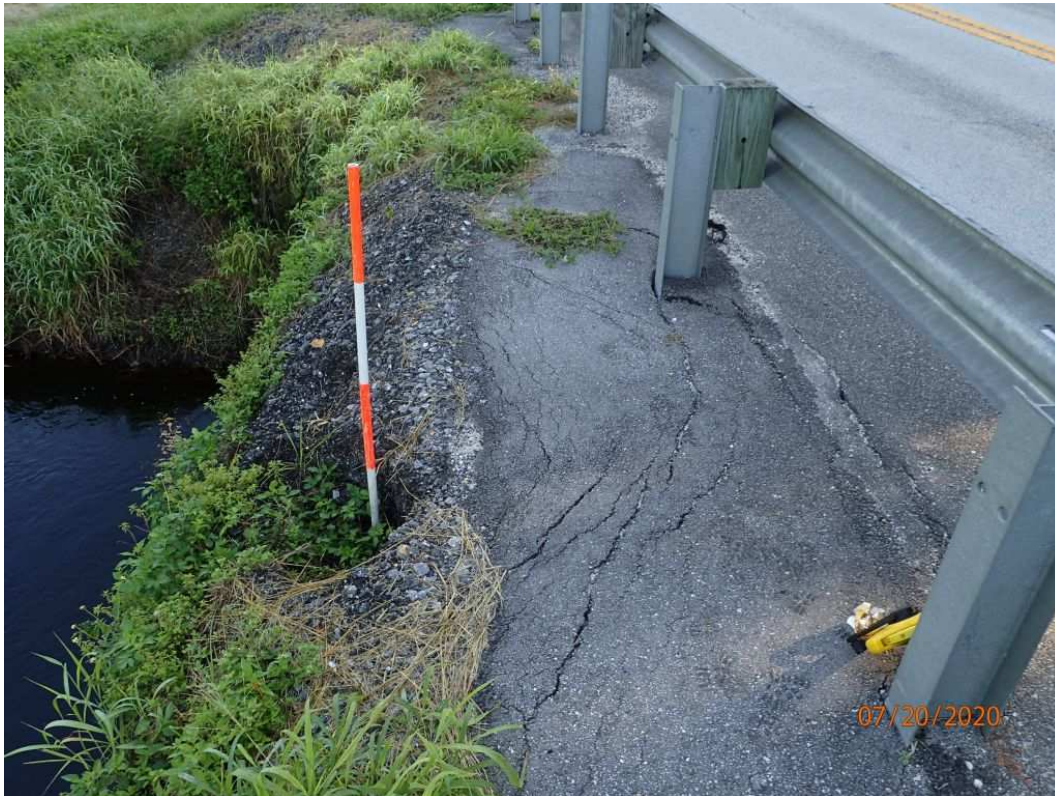
Photo 10: Inspection Notes: Depression over Wall 4 in the asphalt mowing strip

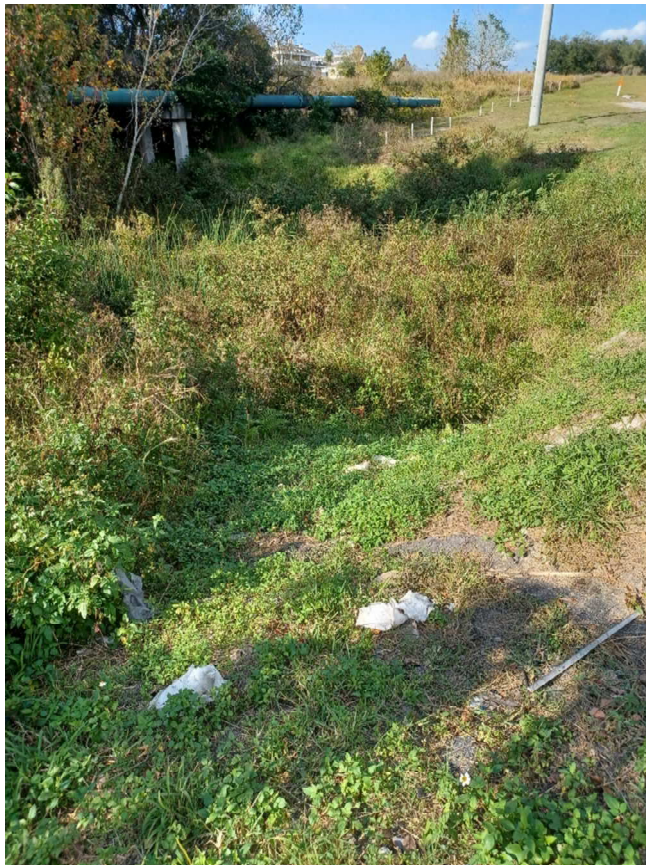
**Photo 2: South side of the channel totally overgrown**

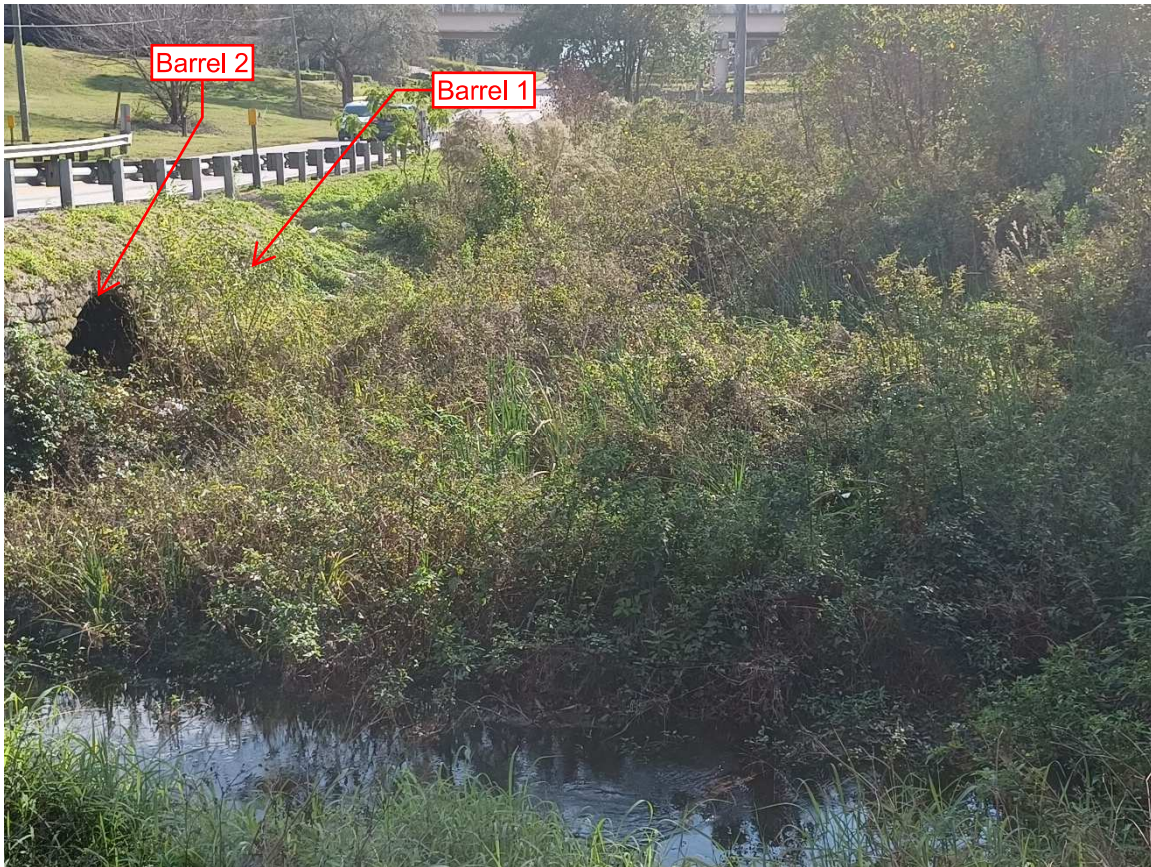
**Photo 3: South side of the channel totally overgrown**

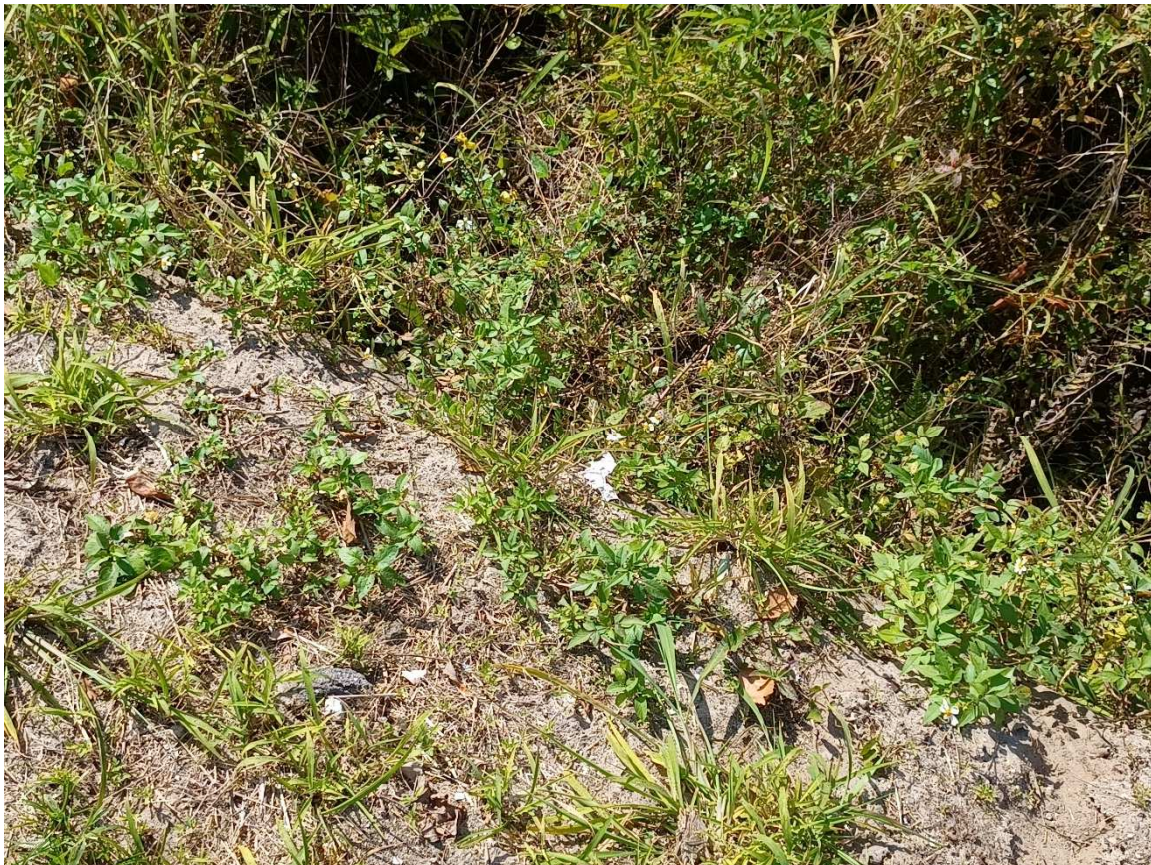
**Photo 4: Barrel 1 – View looking down from top - Totally overgrown, mostly occluded**

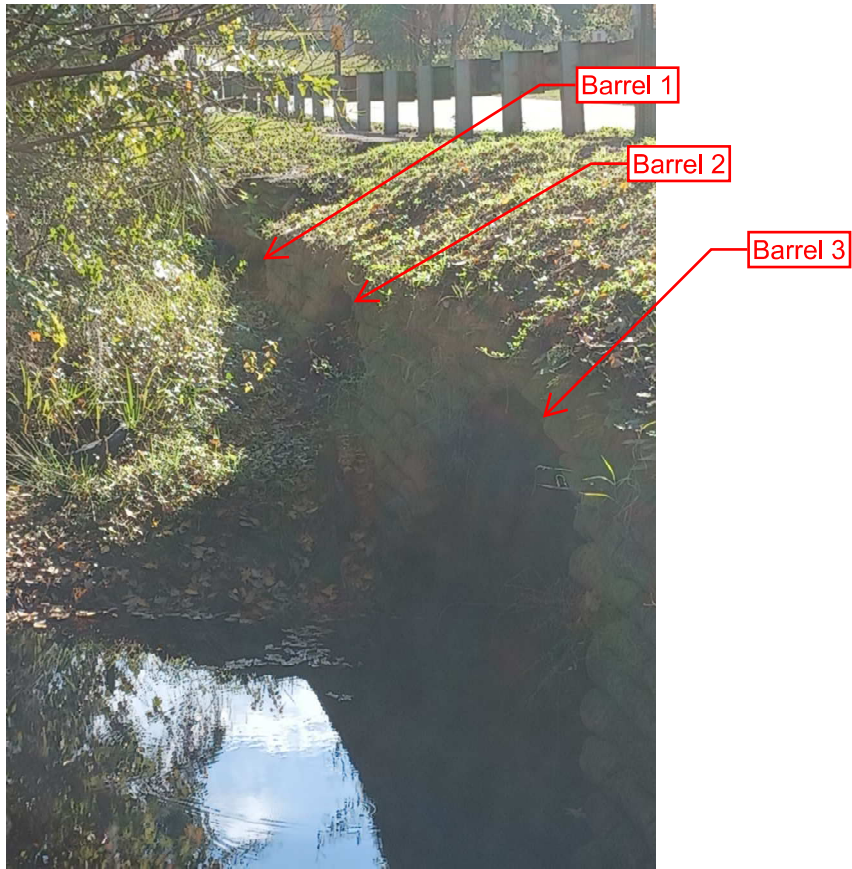
**Photo 7: Occluded Barrels**

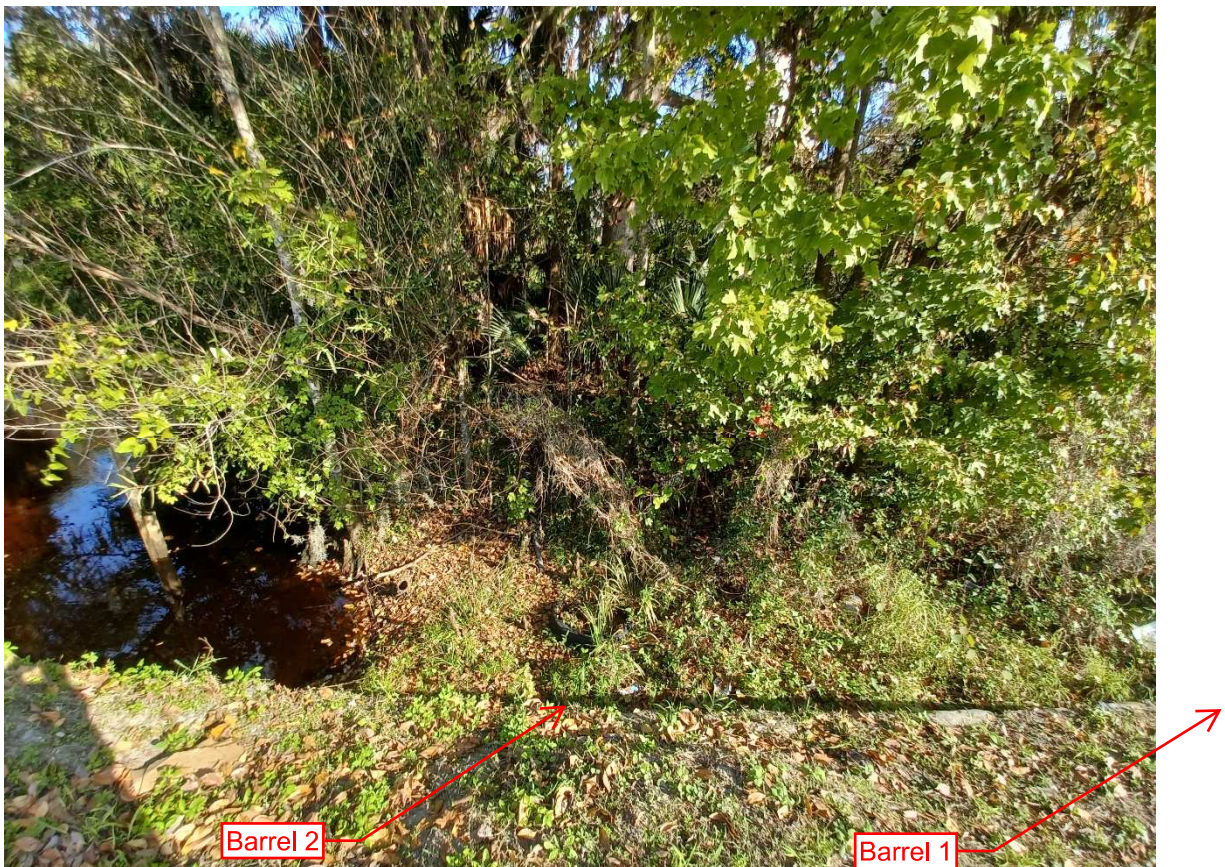
**Photo 8: Vegetative overgrowth in front of Barrels 1 & 2**
