**Reconstruction of Old Lake Wilson Road (CR 545)  
Widening Project Development and Environment (PD&E)  
Study from County Road 532 to South of Sinclair Road**

**Osceola County**

**FINAL CONCEPTUAL BRIDGE HYDRAULICS ASSESSMENT**

**March 2022**

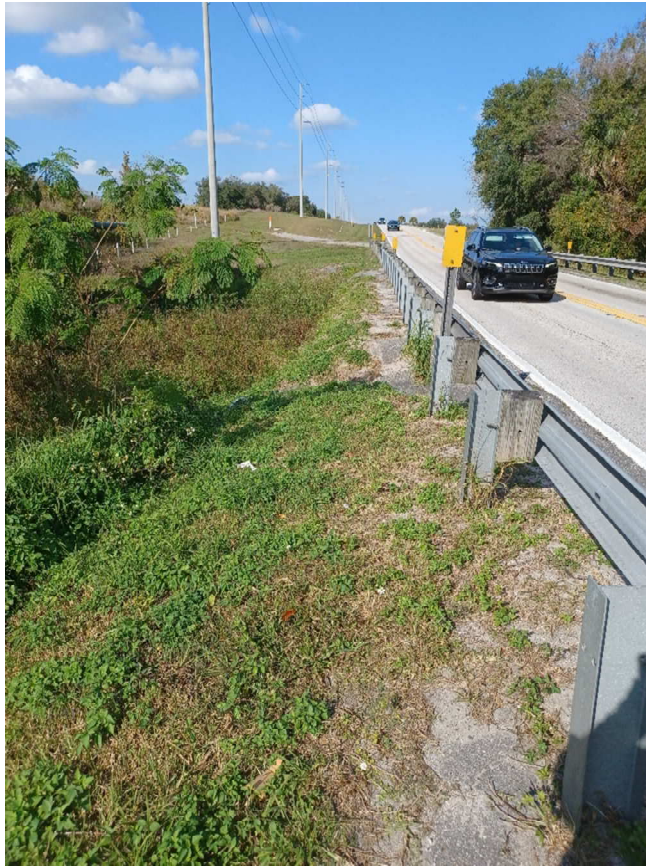
**Photo 1: West side – Facing North**

- A USGS hydrologic monitoring station is located at this crossing.
- Present Water – approximately 5.3’ deep
- Poorly maintained, with multiple locations exhibiting raveling of the miscellaneous asphalt behind the guardrail.
- Channel outside of the “baseflow” is overgrown and heavily vegetated.
- Only the northern 2 barrels (designated barrels 3 & 4 in July 2020 inspection report) are utilized during baseflow conditions.
  - Barrel 2 is approximately 30% to 50% occluded, giving an effective flowline 2 ½’ to 3 ¾’ above the channel bottom.
  - Barrel 1 is approximately 50% to 75% occluded, giving an effective flowline of 3 ¾’ to 5 ½’ above the channel bottom.
- Vegetation downstream of Barrel 1 is well-established, indicating that flow through this barrel is likely infrequent and does not achieve significant velocities.
