# **CONTAMINATION SCREENING EVALUATION REPORT**

**N. Old Lake Wilson Road  
From County Road 532 (Osceola-Polk County Line Road)  
to 730 feet south of Sinclair Road  
Osceola County, Florida  
PS-20-11842-DG**

**Prepared for:  
Osceola County  
Department of Transportation & Transit  
1 Courthouse Square, Suite 3100  
Kissimmee, Florida 34741**

**January 2022**

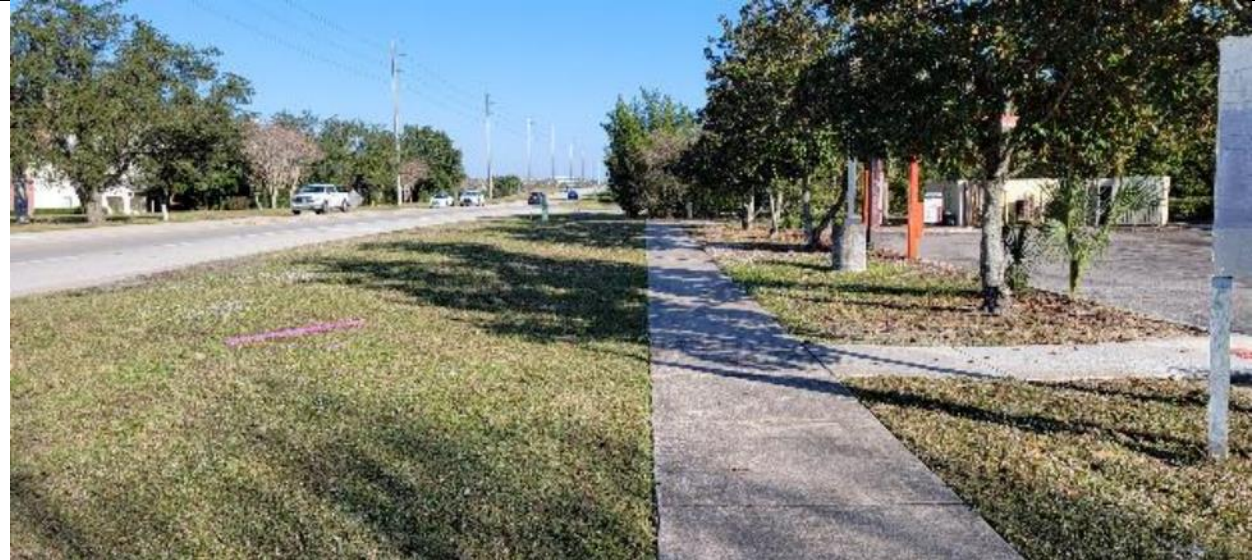
<b>Photo:</b> 1	<b>Date:</b> 12.13.2021	<b>Description:</b> Typical ROW within the south portion of the corridor, facing north. No apparent signs of contamination.
--------------------	----------------------------	-----------------------------------------------------------------------------------------------------------------------------

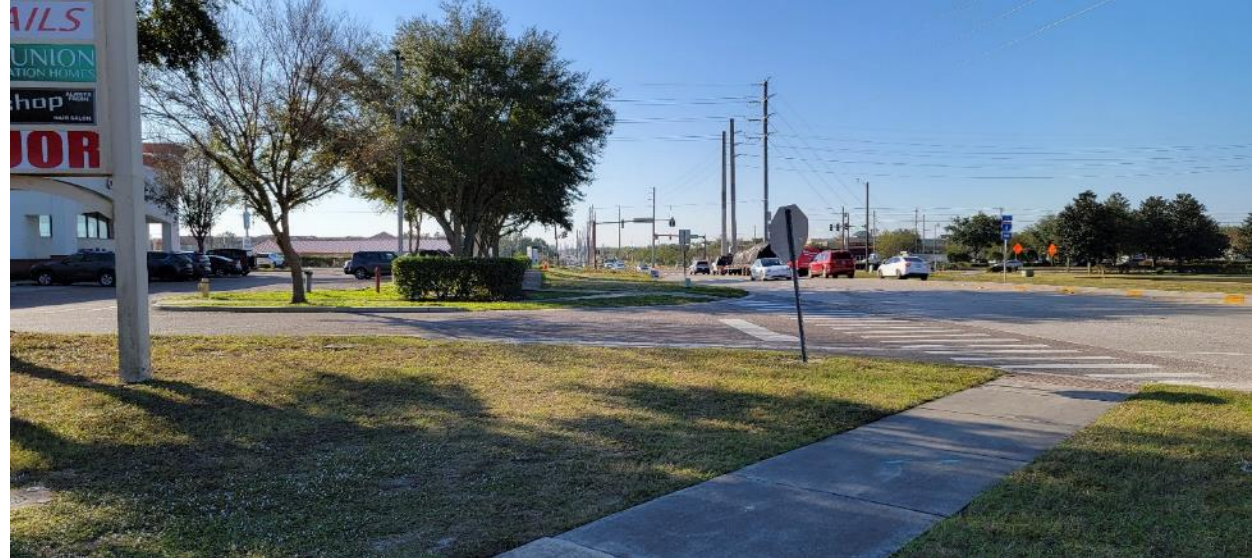
<b>Photo:</b> 2	<b>Date:</b> 12.13.2021	<b>Description:</b> East side of corridor, facing south, near CR 523. No apparent signs of contamination.
--------------------	----------------------------	-----------------------------------------------------------------------------------------------------------

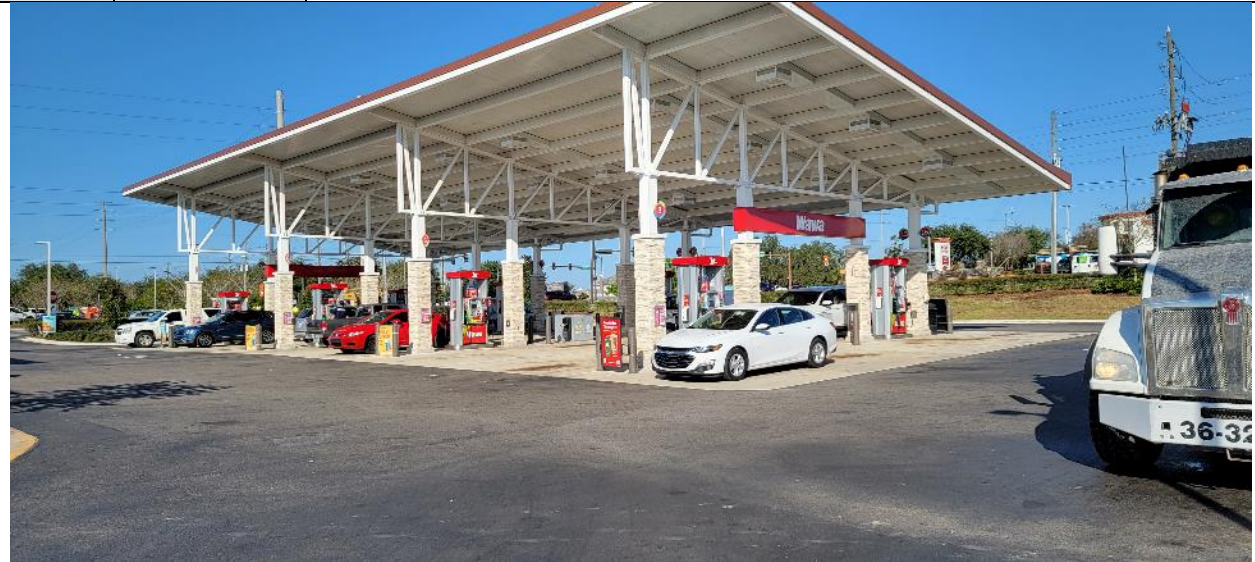
**Description:** Site D15, WAWA Food Mart, facing northwest.

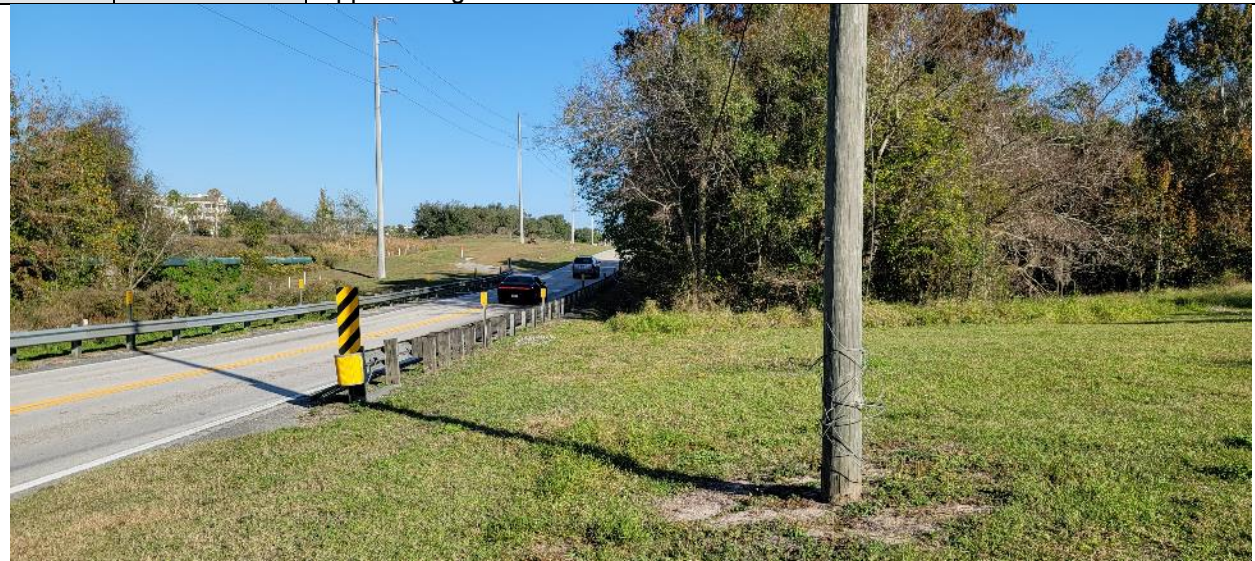
**Photo:**  
4

**Description:** East side of corridor, facing north, at box culvert crossing. No apparent signs of contamination.

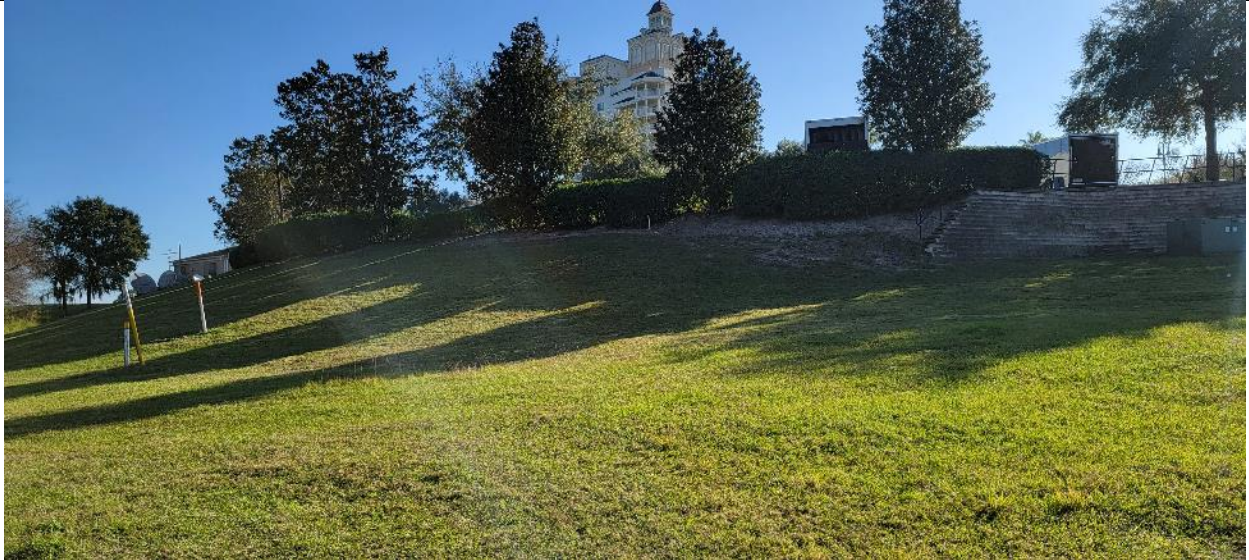
**Description:** ROW adjacent to Reunion Resort and Golf Course, facing northeast.

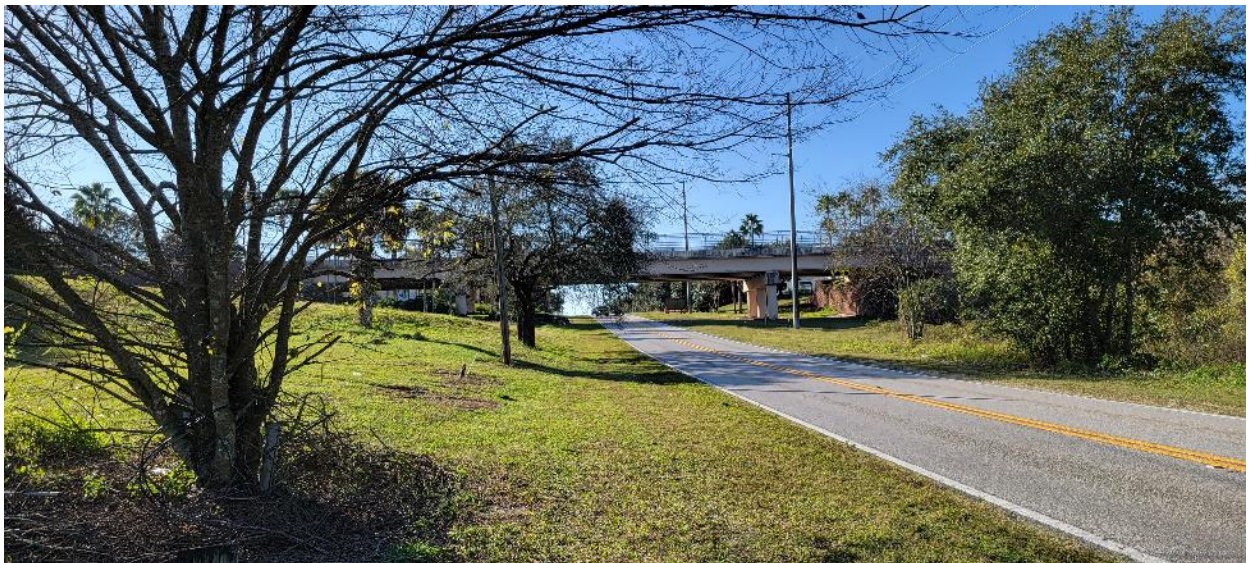
**Photo:**  
6

**Description:** Bridge crossing project corridor from west to east, facing south. No apparent signs of contamination.

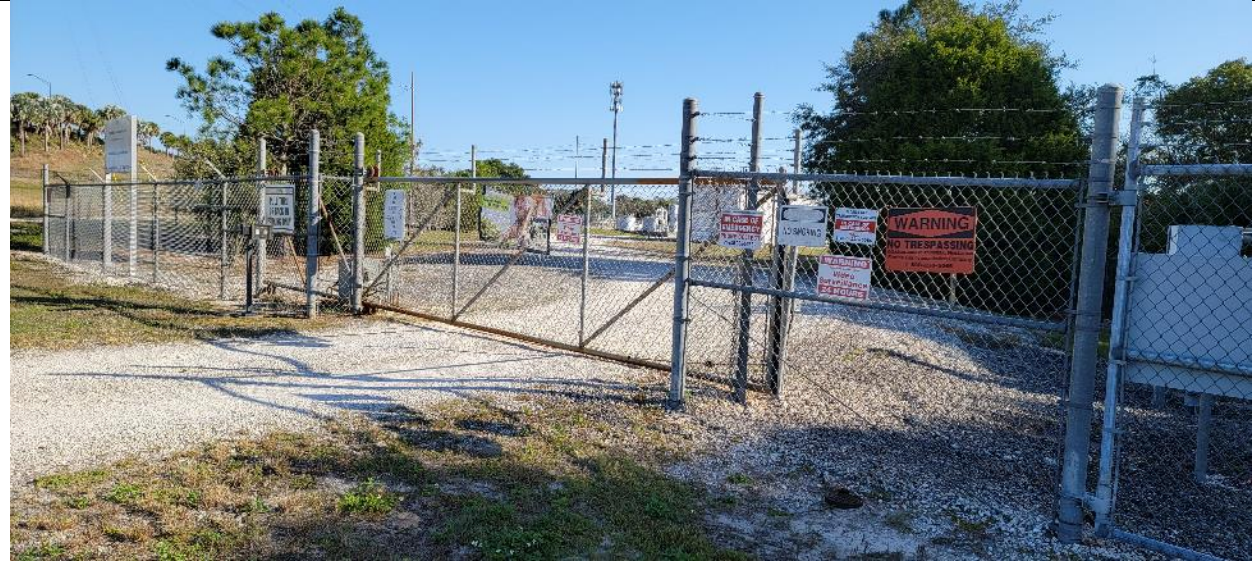
<b>Photo:</b> 7	<b>Date:</b> 12.13.2021	<b>Description:</b> Site A4 through 7 (Florida Gas Transmission) facing northeast. No apparent signs of contamination.
--------------------	----------------------------	------------------------------------------------------------------------------------------------------------------------

A4, A5, A6, A7	110055507820, 1002782	Florida Gas Transmission	727 S. Old Lake Wilson Road	TIER 2, FINDS, ECHO, U.S. AIRS	Natural gas	N	This site is located southeast of the I-4/N. Old Lake Wilson Road intersection. Historical aerials suggest this facility was developed between 1984 and 1995, and records indicate that this facility has a pipeline that transports natural gas. This facility is monitored for GHG emissions. Based on records reviewed, this facility has received no violations. Because natural gas is volatile and does not impact the subsurface, this site was assigned a CRR of no.
B8, B9	9100367	Herman J. Heidrich & Sons, Inc.	1261 S. Old Lake Wilson Road	LUST, UST, RGA LUST	Petroleum and agrochemicals	L	This site historically operated as a citrus grove, which was located approximately 1 mile south of the intersection of N. Old Lake Wilson Road and I-4, along the east side of N. Old Lake Wilson Road. Soil and groundwater contamination were reported from the release of diesel fuel from four 30,000-gallon ASTs. Approximately 100 to 120 tons of excessively contaminated soils were removed, and groundwater monitoring was initiated in 1992. Sampling conducted in 1995 indicated no groundwater exceedances for a period of 2 years. An SRCO was issued for the facility in 1995. This site was subsequently redeveloped and currently operates as Reunion Golf Course. Based on reviewed records, the petroleum product storage systems formerly associated with this facility were assigned a CRR of low.

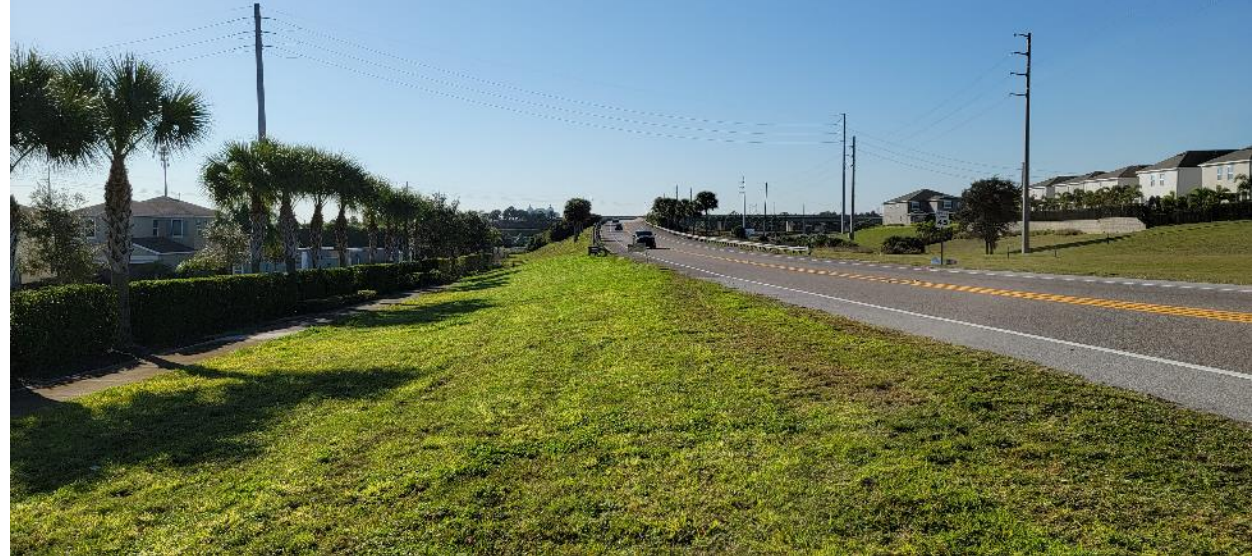
<b>Photo:</b> 8	<b>Date:</b> 12.13.2021	<b>Description:</b> East ROW, facing south, approach to bridge crossing I-4. No apparent signs of contamination.
--------------------	----------------------------	------------------------------------------------------------------------------------------------------------------

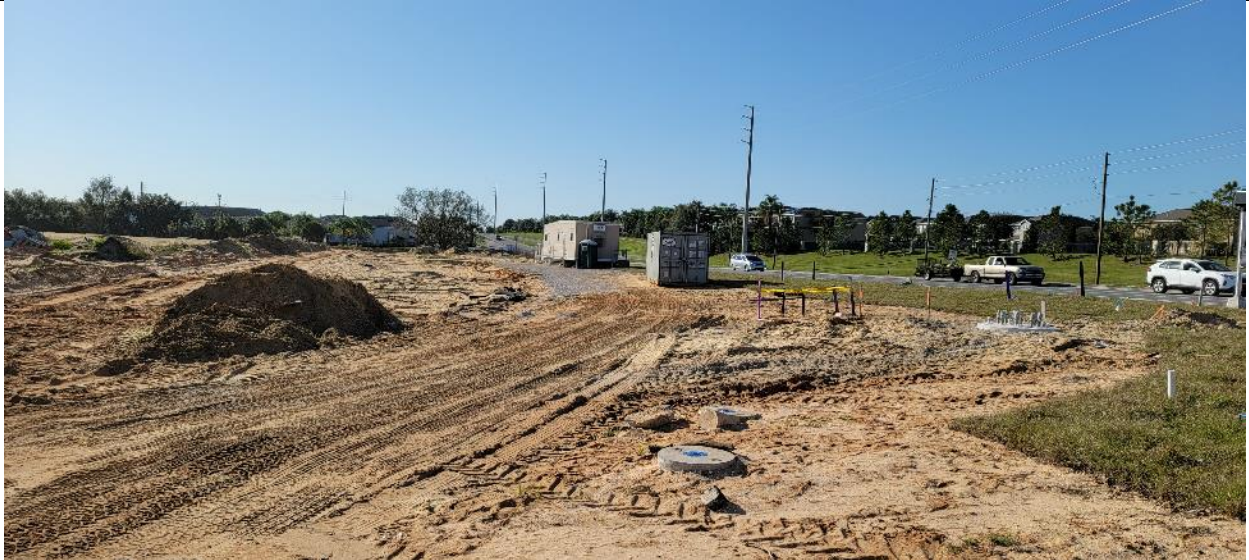
<b>Photo:</b> 9	<b>Date:</b> 12.13.2021	<b>Description:</b> Northern limits of project corridor, east side, facing southwest. Site under construction. No apparent signs of contamination.
--------------------	----------------------------	----------------------------------------------------------------------------------------------------------------------------------------------------

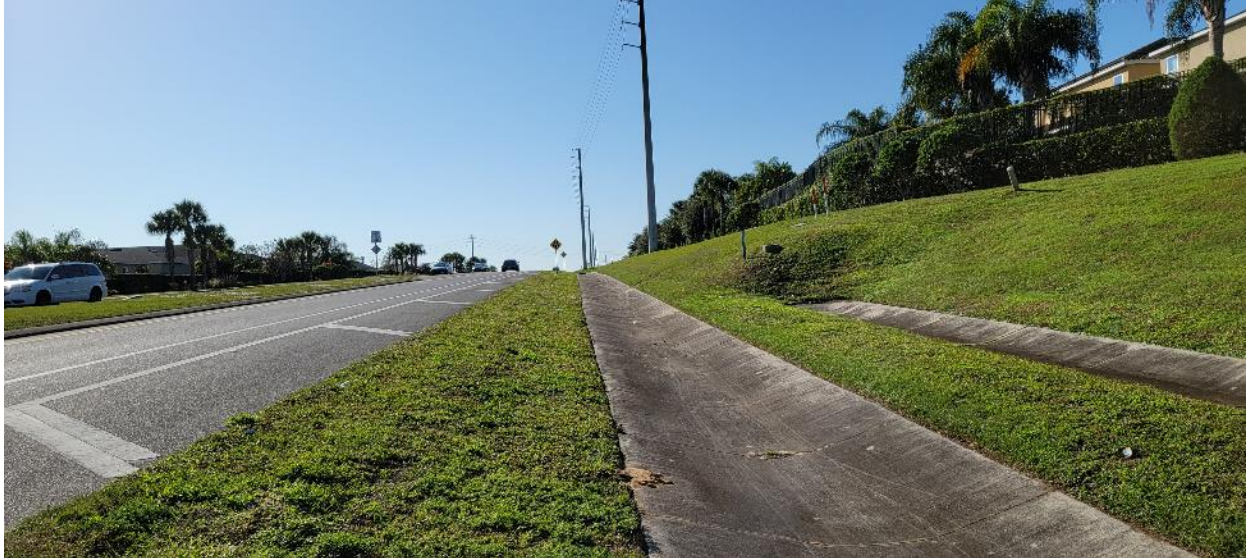
<b>Photo:</b> 10	<b>Date:</b> 12.13.2021	<b>Description:</b> ROW on approach to the overpass of I-4, facing south. No apparent signs of contamination.
---------------------	----------------------------	---------------------------------------------------------------------------------------------------------------

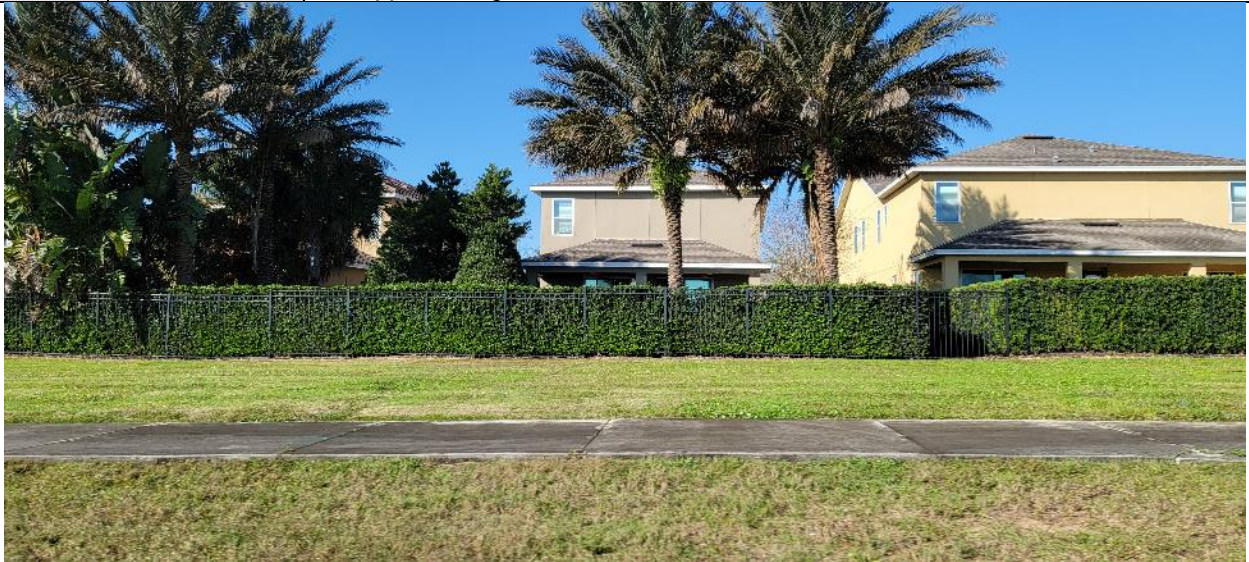
<b>Photo:</b> 11	<b>Date:</b> 12.13.2021	<b>Description:</b> Residential dwellings adjacent to the project corridor, facing west. No apparent signs of contamination.
---------------------	----------------------------	------------------------------------------------------------------------------------------------------------------------------

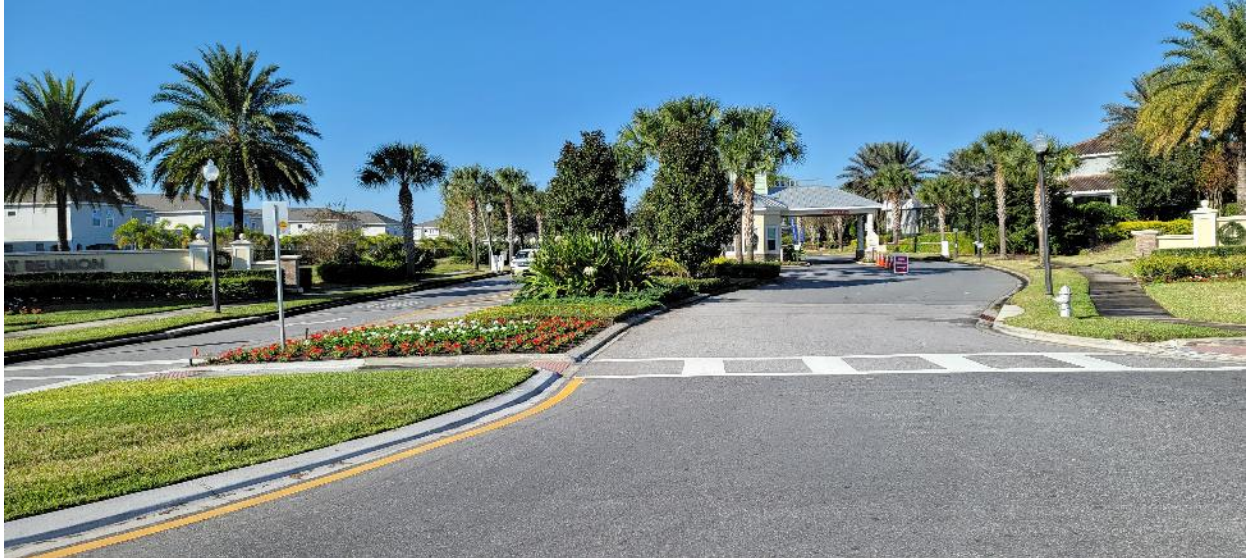
<b>Photo:</b> 12	<b>Date:</b> 12.13.2021	<b>Description:</b> Resort entrance adjacent to project corridor, facing west. No apparent signs of contamination.
---------------------	----------------------------	--------------------------------------------------------------------------------------------------------------------

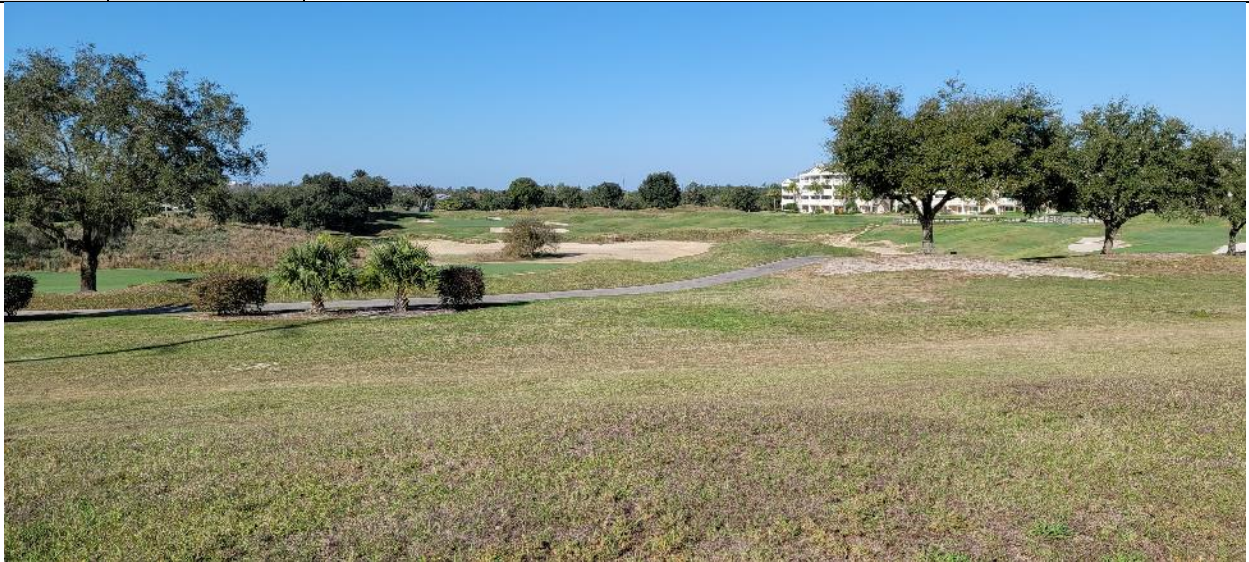
<b>Photo:</b> 13	<b>Date:</b> 12.13.2021	<b>Description:</b> Reunion golf course located west of project corridor, facing west.
---------------------	----------------------------	----------------------------------------------------------------------------------------

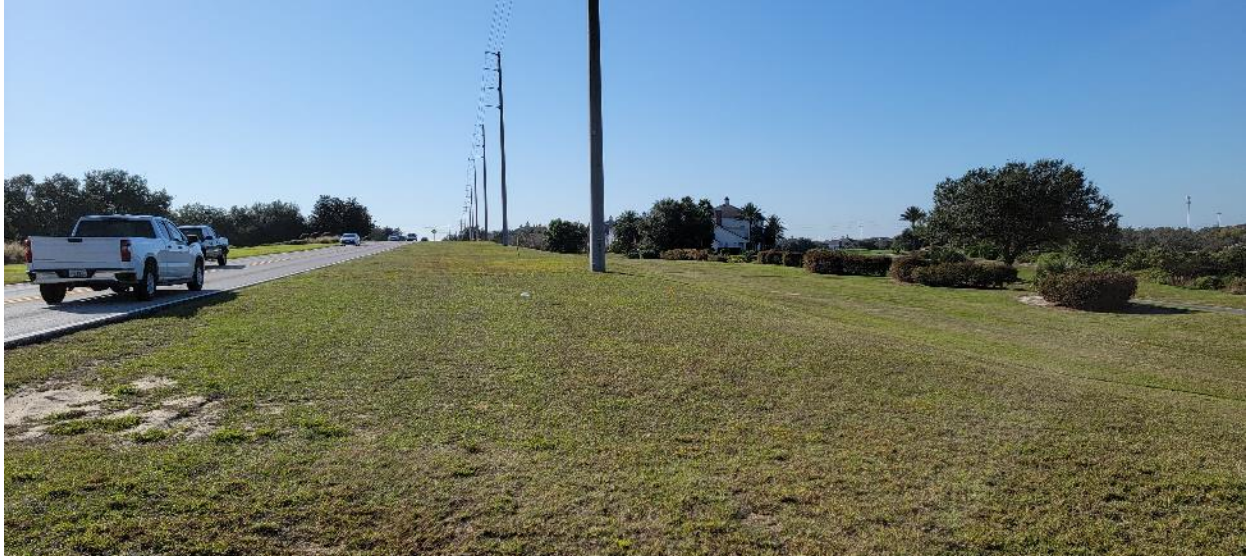
<b>Photo:</b> 14	<b>Date:</b> 12.13.2021	<b>Description:</b> Southbound project corridor, facing south. ROW with utilities adjacent to a golf course.
---------------------	----------------------------	--------------------------------------------------------------------------------------------------------------

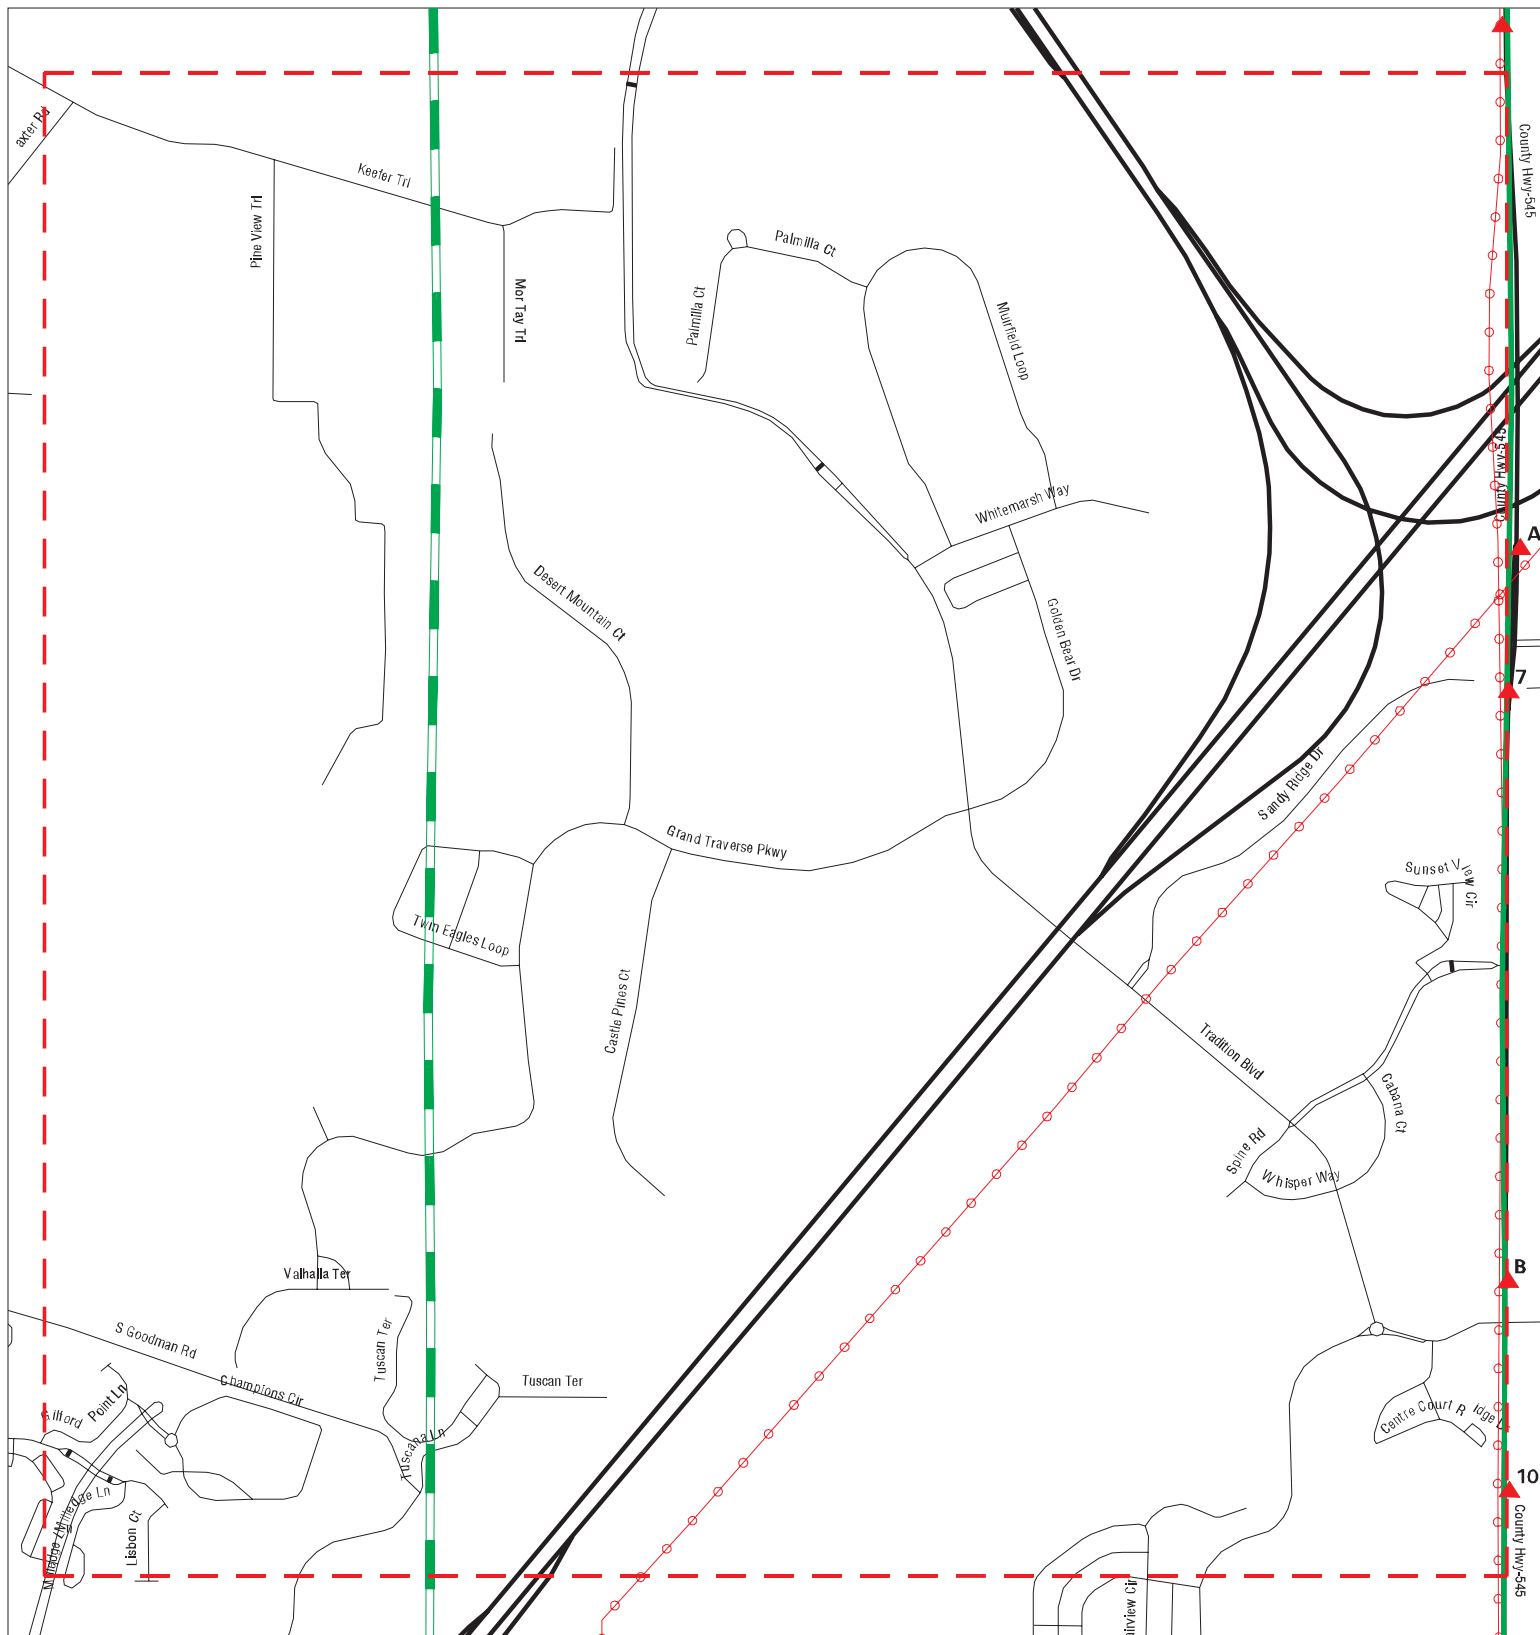
# Focus Map - 3 - 6758861.9s

MAP ID / FOCUS MAP	SITE NAME	ADDRESS	DATABASE ACRONYMS	DIST (ft. & mi.) DIRECTION
1 / 2	I - 4 SR 400 OSCEOLA	SOUTH OF 192 TO OSCE	FINDS	TP
20 / 2	HELLER BROTHERS PACK	2 MILES S OF US 192	LUST, AST	1668 0.316 NNE
21 / 2	BEST DIVERSIFIED INC	945 OLD LAKE WILSON	SWF/LF, CLEANUP SITES, DWM CONTAM, Finan...	2119 0.401 NE

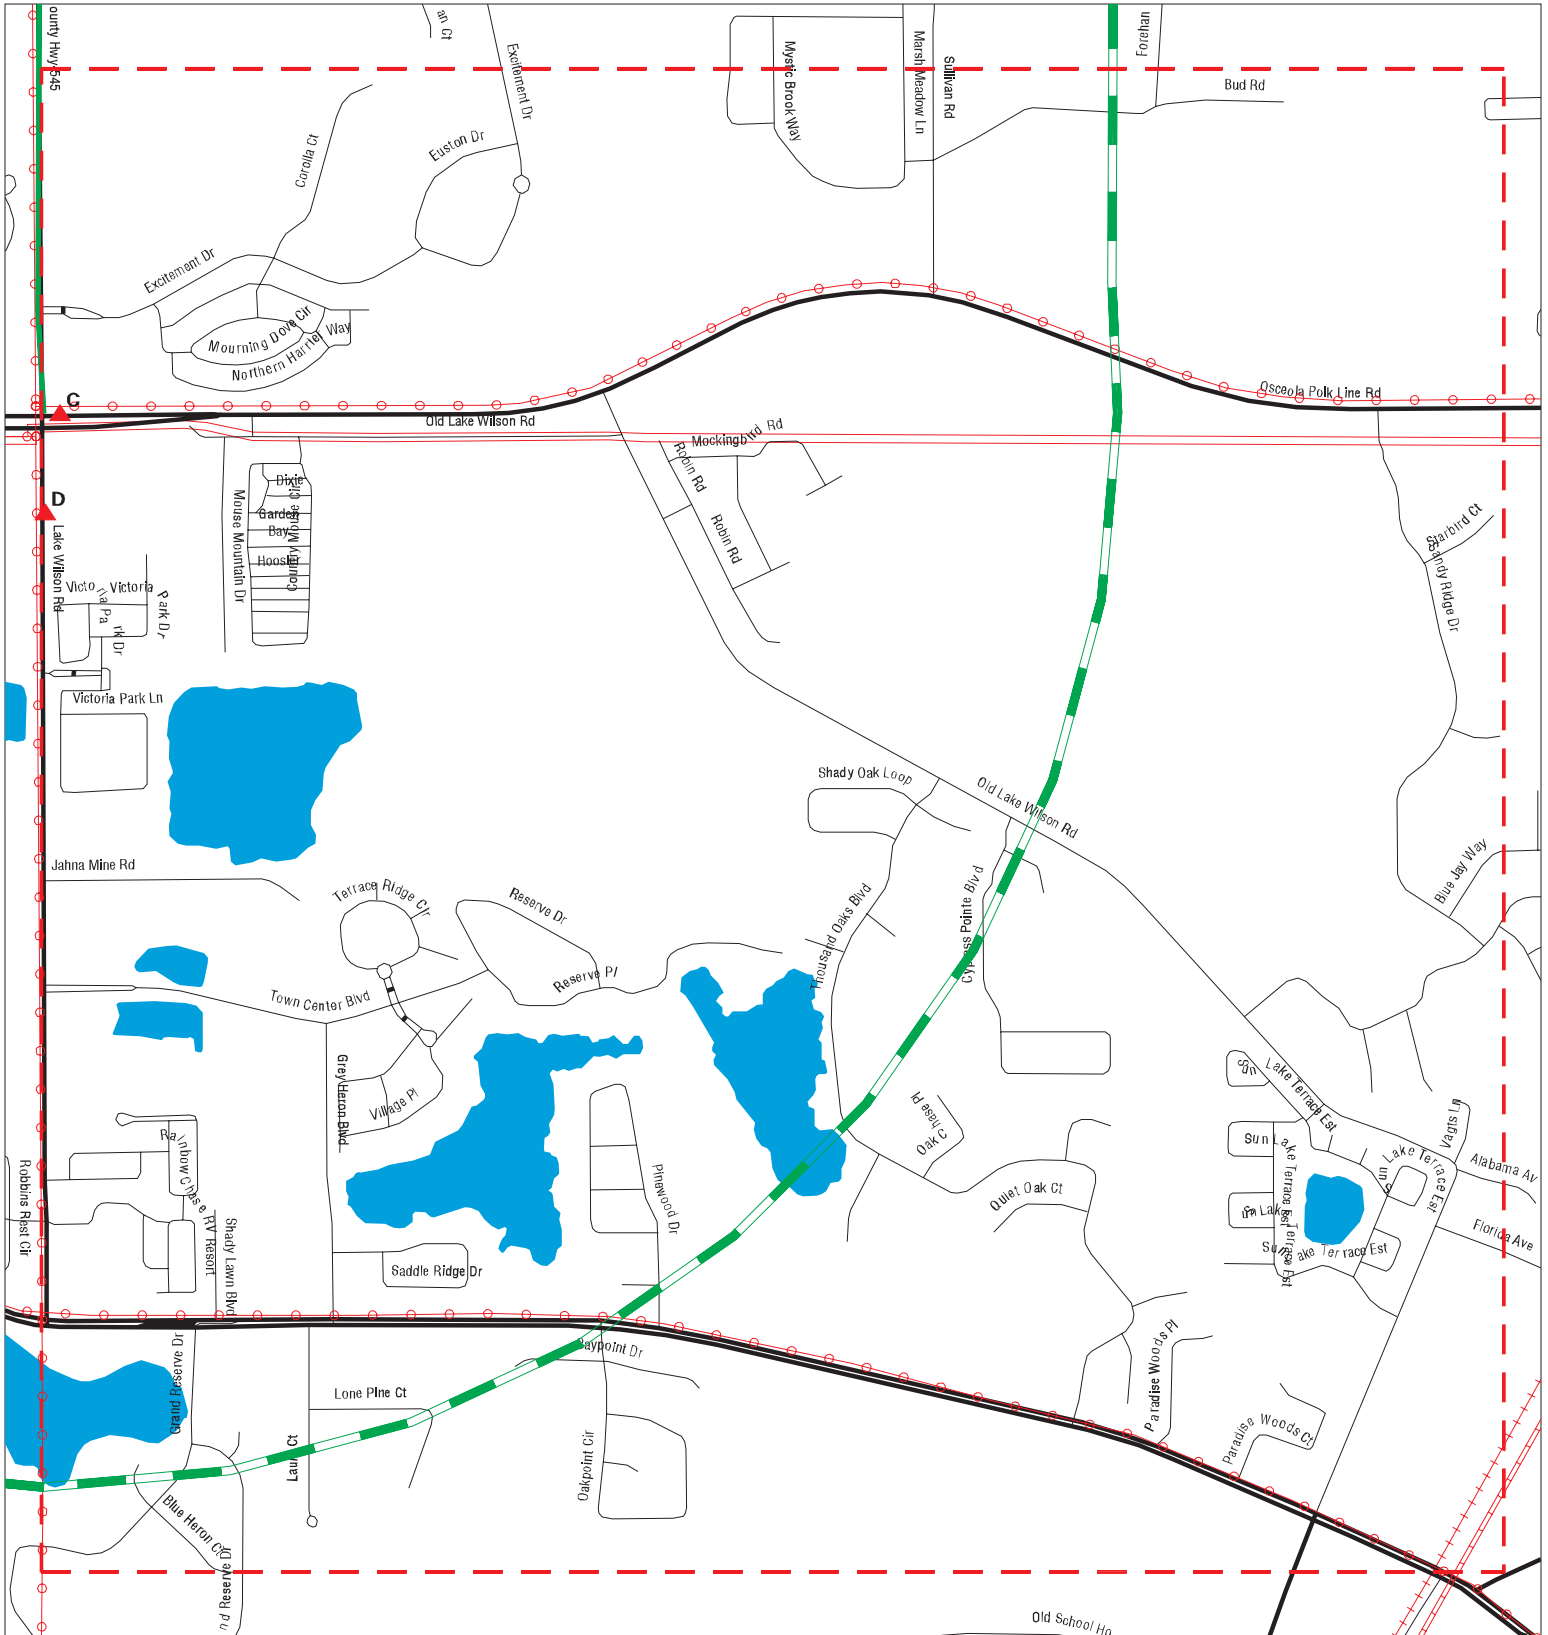
# Focus Map - 6 - 6758861.9s

MAP ID / FOCUS MAP	SITE NAME	ADDRESS	DATABASE ACRONYMS	DIST (ft. & mi.) DIRECTION
C11 / 5	7-ELEVEN	7585 OSCEOLA-POLKLIN	FINDS	TP
17 / 5	PUBLIX SUPER MARKET	7700 OSCEOLA POLK LI	AST	723 0.137 SW
